# Manhole Inspection Summary

Manhole # S49A\_\_025MH

Insp Date: **5/6/08 1:51 PM**

**Location** Address: **rear 511 n lakewood ave**

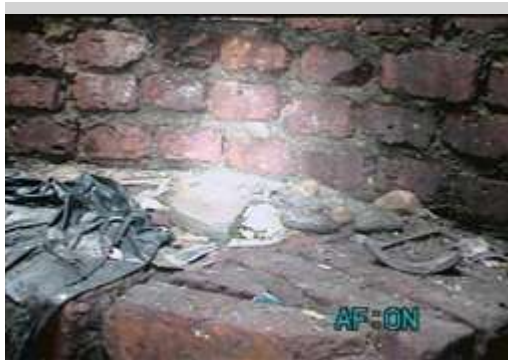
Misc

bench debris

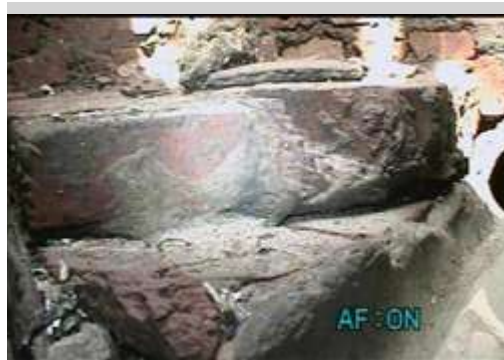
Defect 4

Condition: ☐ Sound ☐ Cracked ☐ Root Intrusion ☒ **Deteriorated** ☐ Leaks ☐ Debris

brick missing in bench, deteriorated

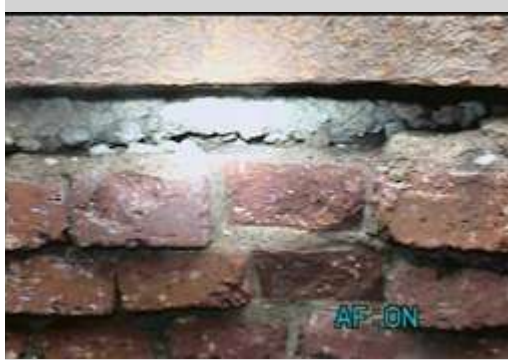
Defect 3

Condition: ☐ Sound ☐ Cracked ☐ Root Intrusion ☐ Loose Brick ☒ **Deteriorated**

deteriorated, frame adjustment

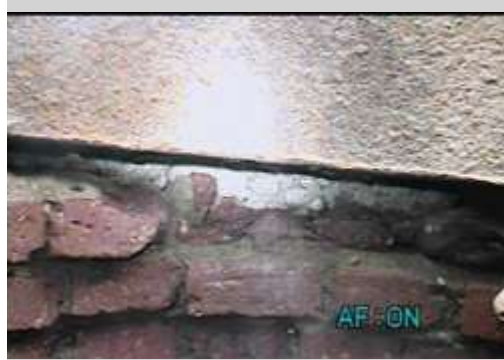
Defect 2

Condition: ☐ Sound ☐ Cracked ☐ Root Intrusion ☒ **Loose Brick** ☒ **Deteriorated**

brick missing in corbel, deteriorated

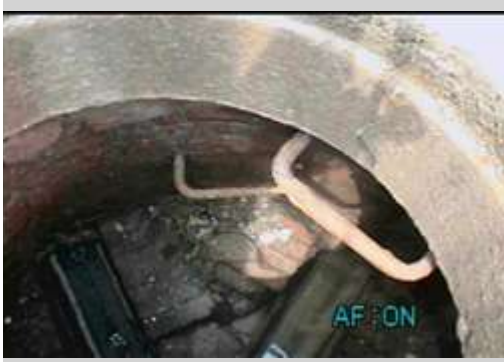
### Defect 1

Count: **2** Missing: **0** ☒ **Corroded**

steps

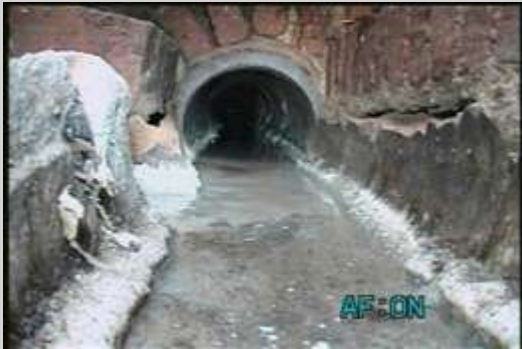
12 O'Clock Outflow

8 in. Circular Gravity Sewer  
Pipe Out @ 12 O'Clock

Invert Depth: **5.92** (ft.) Flow Characteristics: **Fast**

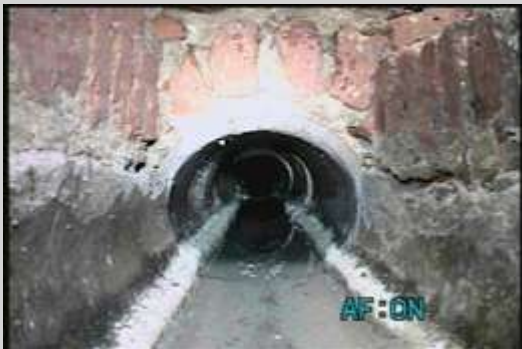
6 O'Clock Inflow

8 in. Circular Gravity Sewer  
Pipe In @ 6 O'Clock

Invert Depth: **5.90** (ft.) Flow Characteristics: **Slow**

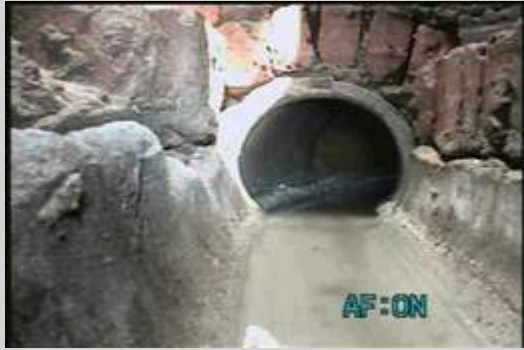
8 O'Clock Inflow

Pipe In @ 8 O'Clock

Invert Depth: **5.87** (ft.) Flow Characteristics: **Fast**
